Cleaning Procedure of Exhaust Area

This is an addendum to the Operator's Guide of Can-Am Commander model year 2011, 2012 and 2013 vehicles.

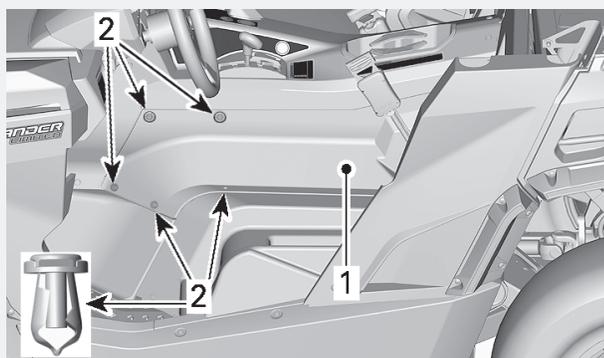
FRONT PORTION OF THE LH LATERAL CONSOLE PANEL
1. LH lateral console panel
2. Plastic rivets

2.1 Remove plastic rivets securing the lateral console panel and keep for reinstallation later on.

2.2 Remove the lateral console panel.

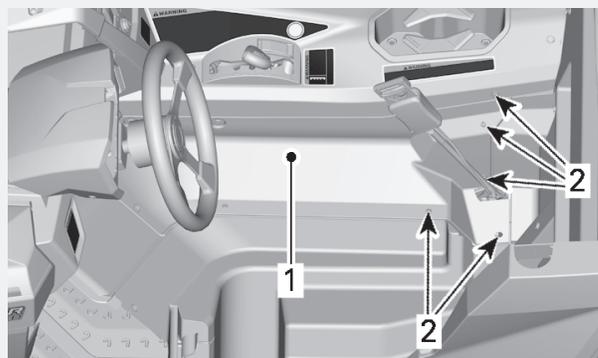
REAR PORTION OF THE LH LATERAL CONSOLE PANEL
1. LH lateral console panel
2. Plastic rivets

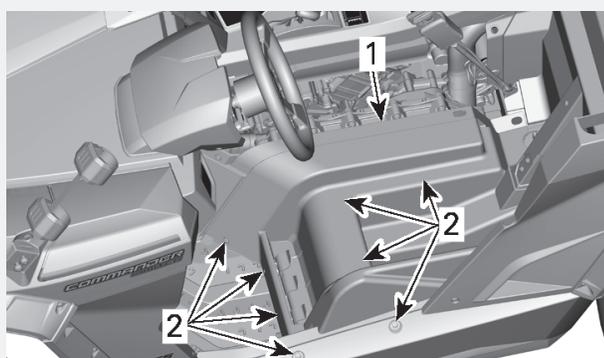
1. Under seat storage compartment
2. Plastic rivets

3.1 Remove plastic rivets securing the under seat storage compartment and keep for reinstallation later on.

3.2 Remove under seat storage compartment. This part will still be attached to the vehicle by the seat belt.

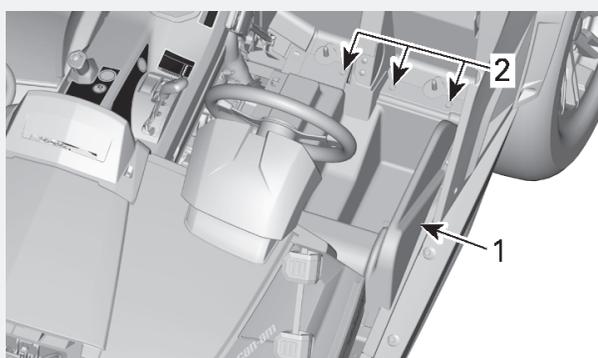
1. Under seat storage compartment
2. Plastic rivets
